MAINTENANCE & RELIABILITY

Bearing Failure Investigation

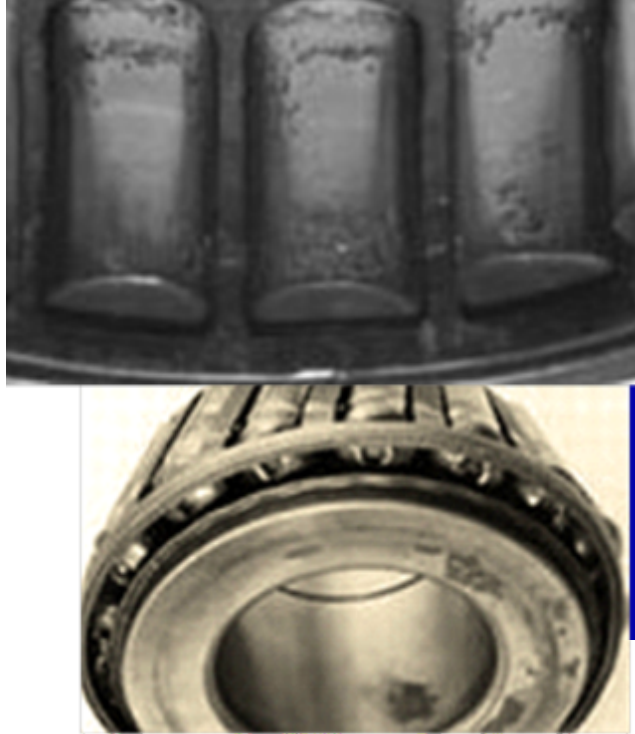
A large process machine was experiencing repeated angular rolling element thrust bearing failures. The periodic vibration data collected by the operator showed limited trend information. Insufficient information immediately prior to failure meant no clear indication of cause of failure.

The initial review of documentation confirmed that the angular contact bearings installed were correct bearings. We were able to gather data from the site DCS for the bearing temperature probes. These appeared to show no significant change from normal operating temperature, however, when examined in more detail, this was also found to be the case when the machine was off. As we investigated the field wiring for the temperature instrumentation, we discovered that the temperature probes had been disconnected from the system and load resistors had been connected across the barriers instead to 'simulate' normal operating conditions. Through the course of the investigation it was also discovered that the motor and gearbox driving the machine had been uprated to allow increased production. This had been done to allow the plant to move to a campaign-running regime to reduce utility costs. Analysis of the lubricating oil at the time of failure showed no contamination from any sources other than the damaged bearing.

A temporary system was installed to measure the end float of the machine during operation. Over a period of around three months, it was determined that changing process conditions were causing shuttling of the machine shaft. As a result of the uprating of the machine, the thrust bearing was not capable of sustaining the increased loading. Since the bearing temperature monitors were reconnected, they were regularly in a warning state. The short term solution to the problem was to re-rate the machine, reducing machine loading, and also change the control logic for the upstream process so that the process conditions that were causing the shaft shuttling were prevented. A business review was planned to determine whether it was cost effective to upgrade or replace the machine to allow increased production again.
