# SYSTEM INTEGRATION

## Control Panel Retrofit Upgrade

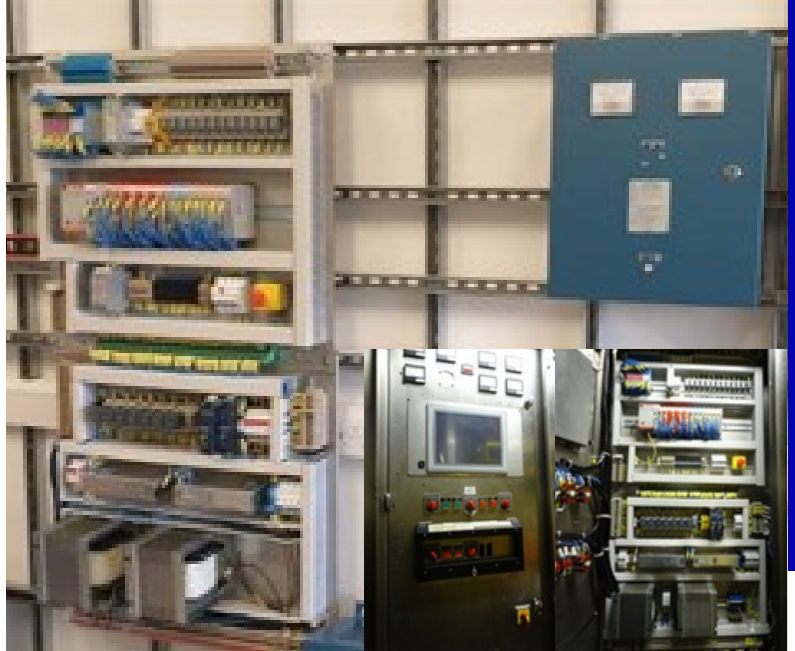
Our client had a number of ageing firewater pump control panels (in excess of 40 years old) which were no longer supported by the OEM. These systems were experiencing severe reliability issues; contributing to lost production on a number of their assets.

The system used a non-standard operating voltage, and other vendors would only quote for a complete system replacement, including all field instrumentation and hardware. The client felt this option would take too long, cost too much and introduce too much risk.

An initial basic survey of the existing packages was performed by Metron. At the same time, we were also able to provide some initial short-term onshore and offshore support to improve their current reliability. This included on-site fault finding & repairs, sourcing of obsolete critical spares and providing re-engineered replacements of the most unreliable components as a temporary stopgap.

After agreeing a detailed statement of requirements with our client and their core staff; we completed all the design and drawings in-house, ready for manufacture. Fabrication, programming, and onshore testing was then completed by our engineers at our Aberdeenshire facility. A purpose-built test-system was additionally constructed to facilitate comprehensive testing prior to release.

After a successful witness FAT with our client, we mobilised offshore to execute installation and commissioning the panels. This was completed whilst maintaining minimum availability of the client's fire water pumps.
